Logbook Photo #	SDC10033
US EPA ID / Task Order Number	CERCLIS No. LAD008434185 / 2/Dynamac-077-15-001
Site	SBA Shipyard, Inc. – Removal Assessment (RA)
Location Address	9040 Castex Landing Road
City, State	Jennings, Louisiana
Parish	Jefferson Davis
Direction/Orientation	NW
Date	10/15/14
Time	0853 hrs
Photographer	J. Sherrard (START)
Witness	N. Biscocho (START)
Description:	
Current condition of the buried barge associated with the alkyne storage tank pump house.	
Southeast corner of the alkyne storage tank pump house facing northwest toward the barge slip inlet.

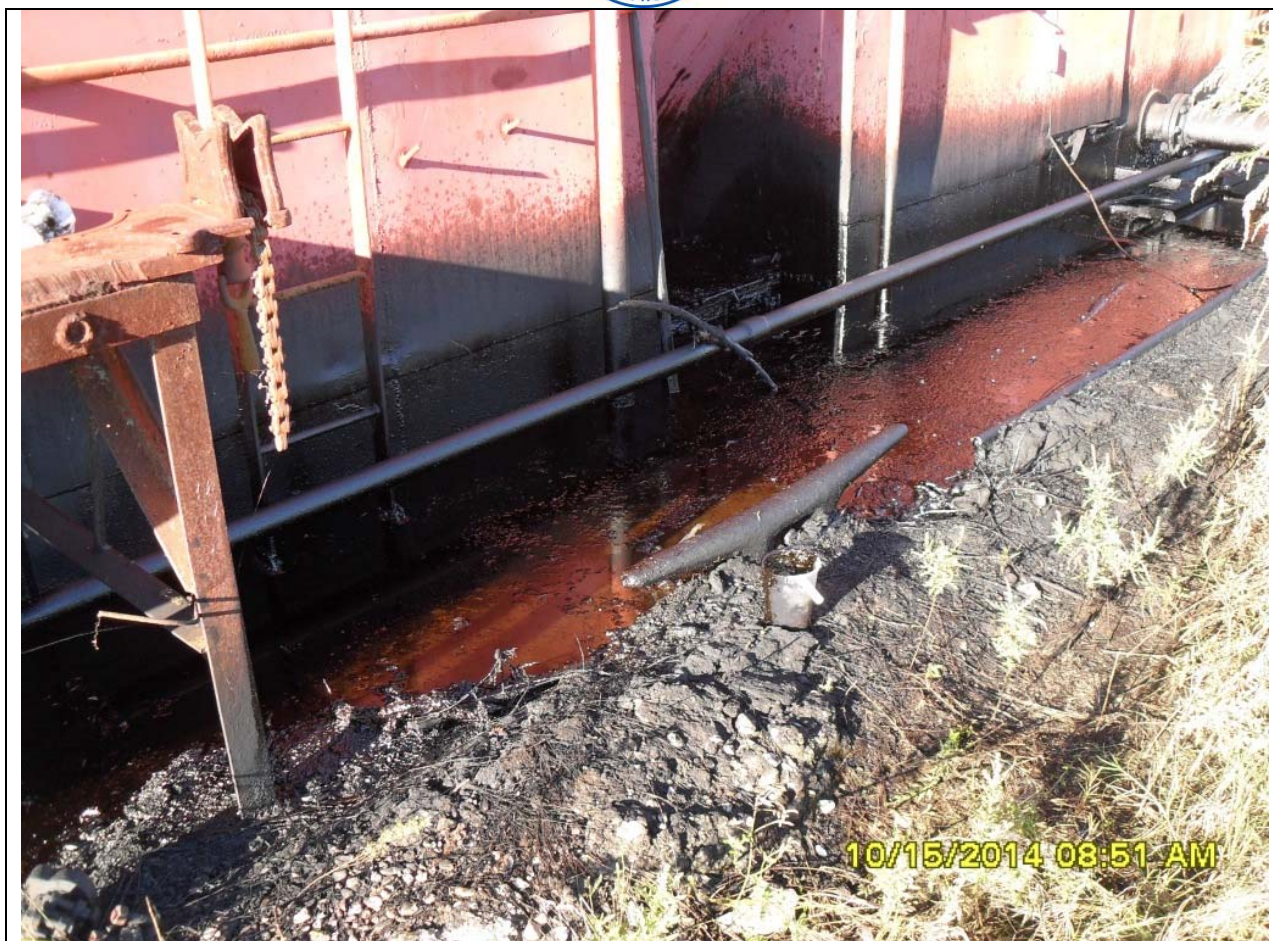
Logbook Photo #	SDC10022
US EPA ID / Task Order Number	CERCLIS No. LAD008434185 / 2/Dynamac-077-15-001
Site	SBA Shipyard, Inc. – Removal Assessment (RA)
Location Address	9040 Castex Landing Road
City, State	Jennings, Louisiana
Parish	Jefferson Davis
Direction/Orientation	W
Date	10/15/14
Time	0851 hrs
Photographer	N. Biscocho (START)
Witness	J. Sherrard (START)
Description: (Photo 1 of 4 from SBA-RA-01) View of sample location SBA-RA-01 located on the north side of the buried barge associated with the alkyne storage tank pump house. Facing southwest at sample location SBA-RA-01.

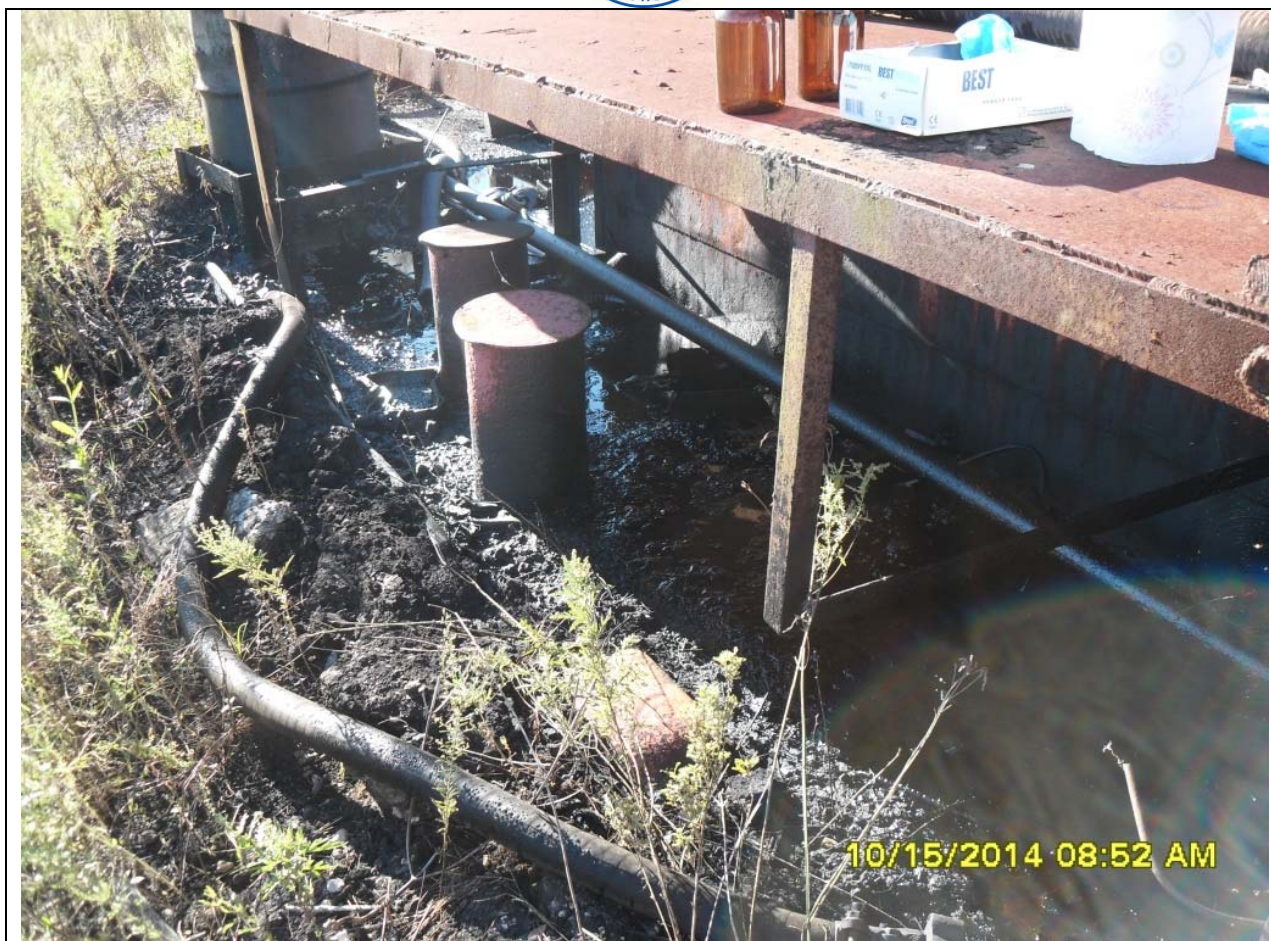
Logbook Photo #	SDC10025
US EPA ID / Task Order Number	CERCLIS No. LAD008434185 / 2/Dynamac-077-15-001
Site	SBA Shipyard, Inc. – Removal Assessment (RA)
Location Address	9040 Castex Landing Road
City, State	Jennings, Louisiana
Parish	Jefferson Davis
Direction/Orientation	SE
Date	10/15/14
Time	0852 hrs
Photographer	N. Biscocho (START)
Witness	J. Sherrard (START)
Description: (Photo 2 of 4 from SBA-RA-01) View of sample location SBA-RA-01 located on the north side of the buried barge associated with the alkyne storage tank pump house. Facing southeast at sample location SBA-RA-01.

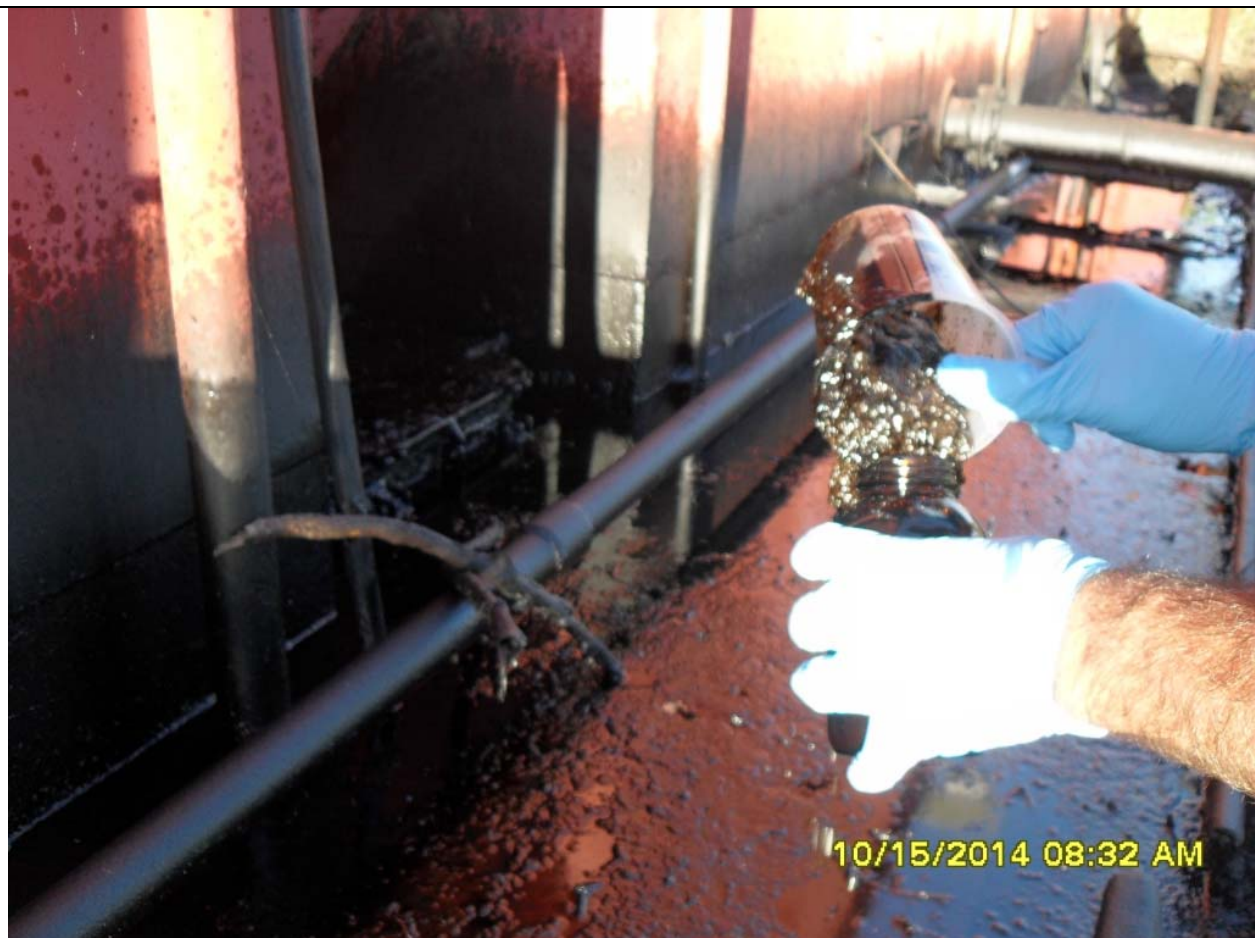
Logbook Photo #	SDC10021
US EPA ID / Task Order Number	CERCLIS No. LAD008434185 / 2/Dynamac-077-15-001
Site	SBA Shipyard, Inc. – Removal Assessment (RA)
Location Address	9040 Castex Landing Road
City, State	Jennings, Louisiana
Parish	Jefferson Davis
Direction/Orientation	W
Date	10/15/14
Time	0832 hrs
Photographer	N. Biscocho (START)
Witness	J. Sherrard (START)
Description: (Photo 3 of 4 from SBA-RA-01) START collecting sediment sample from SBA-RA-01 along the north wall of the buried barge associated with the alkyne storage tank pump house. SBA-RA-01 sample: black in color; hydrocarbon odor; oil/grease sludge nature.

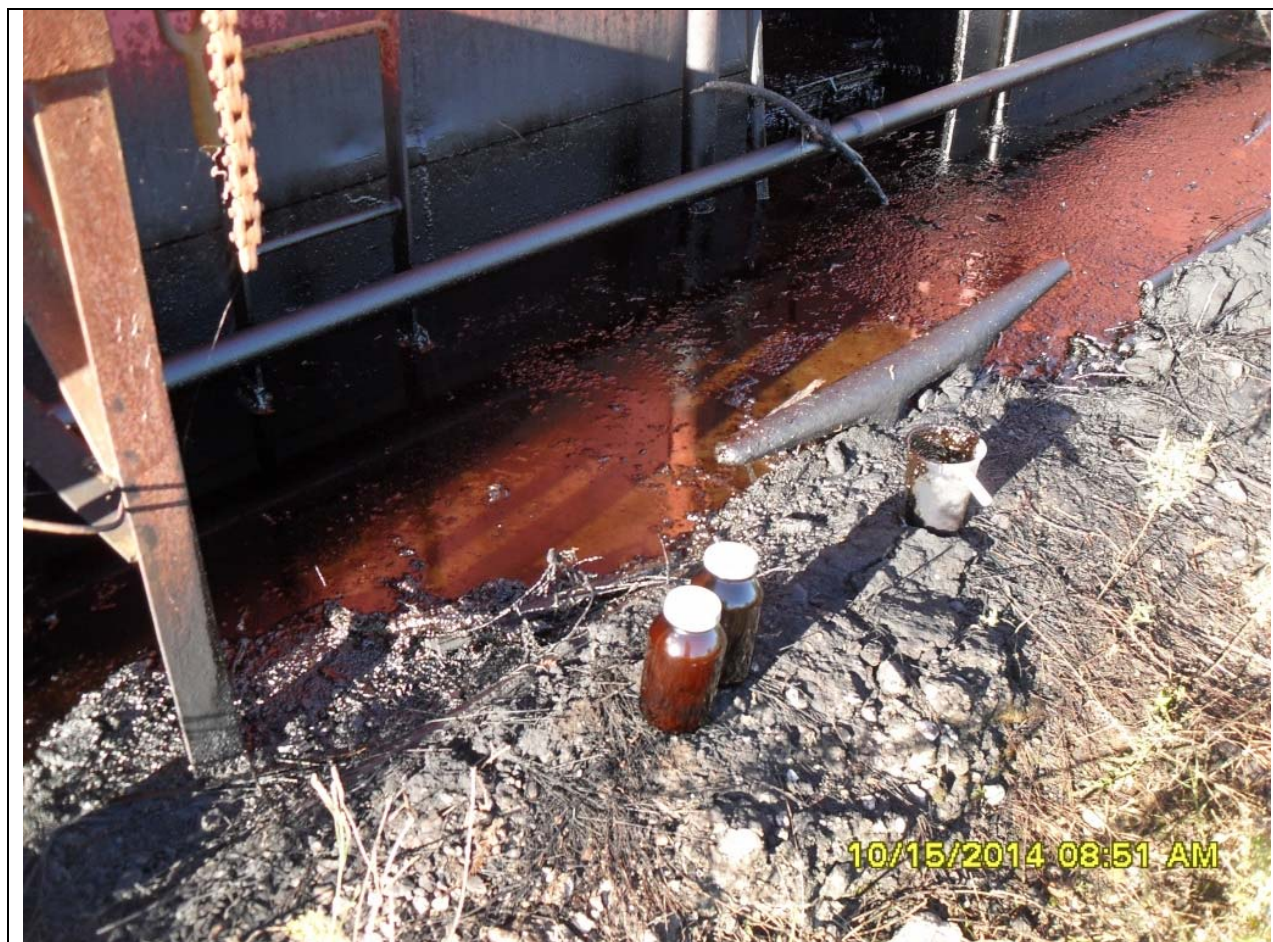
Logbook Photo #	SDC10023
US EPA ID / Task Order Number	CERCLIS No. LAD008434185 / 2/Dynamac-077-15-001
Site	SBA Shipyard, Inc. – Removal Assessment (RA)
Location Address	9040 Castex Landing Road
City, State	Jennings, Louisiana
Parish	Jefferson Davis
Direction/Orientation	W
Date	10/15/14
Time	0851 hrs
Photographer	N. Biscocho (START)
Witness	J. Sherrard (START)
Description: (Photo 4 of 4 from SBA-RA-01) Collected sediment sample from SBA-RA-01 along the north wall of the buried barge associated with the alkyne storage tank pump house.

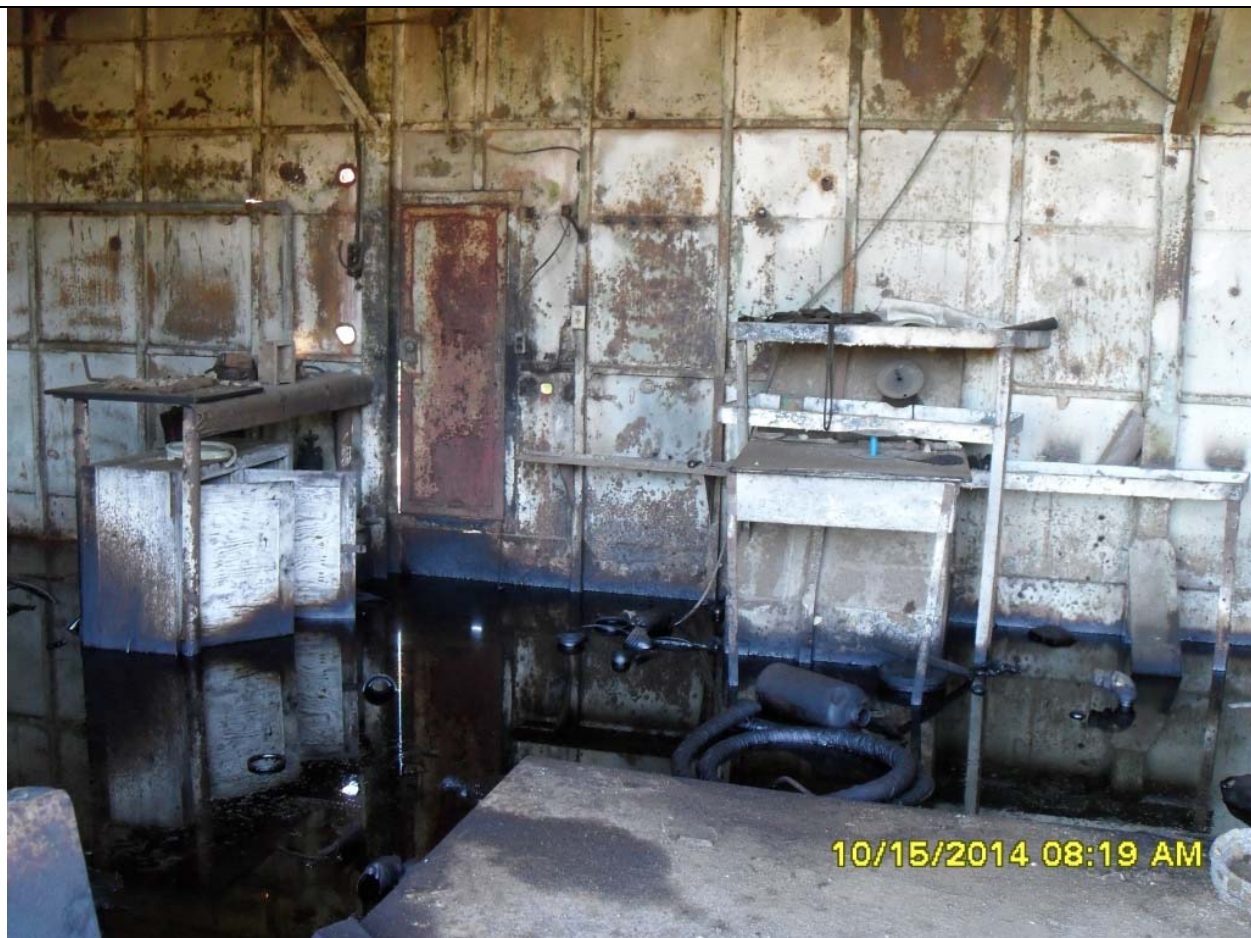
Logbook Photo #	SDC10009
US EPA ID / Task Order Number	CERCLIS No. LAD008434185 / 2/Dynamac-077-15-001
Site	SBA Shipyard, Inc. – Removal Assessment (RA)
Location Address	9040 Castex Landing Road
City, State	Jennings, Louisiana
Parish	Jefferson Davis
Direction/Orientation	NW
Date	10/15/14
Time	0819 hrs
Photographer	N. Biscocho (START)
Witness	J. Sherrard (START)
Description: (Photo 1 of 2 from SBA-RA-02) View of sample location SBA-RA-02 inside the alkyne storage tank pump house visible on the buried barge. Facing northeast at sample location SBA-RA-01.

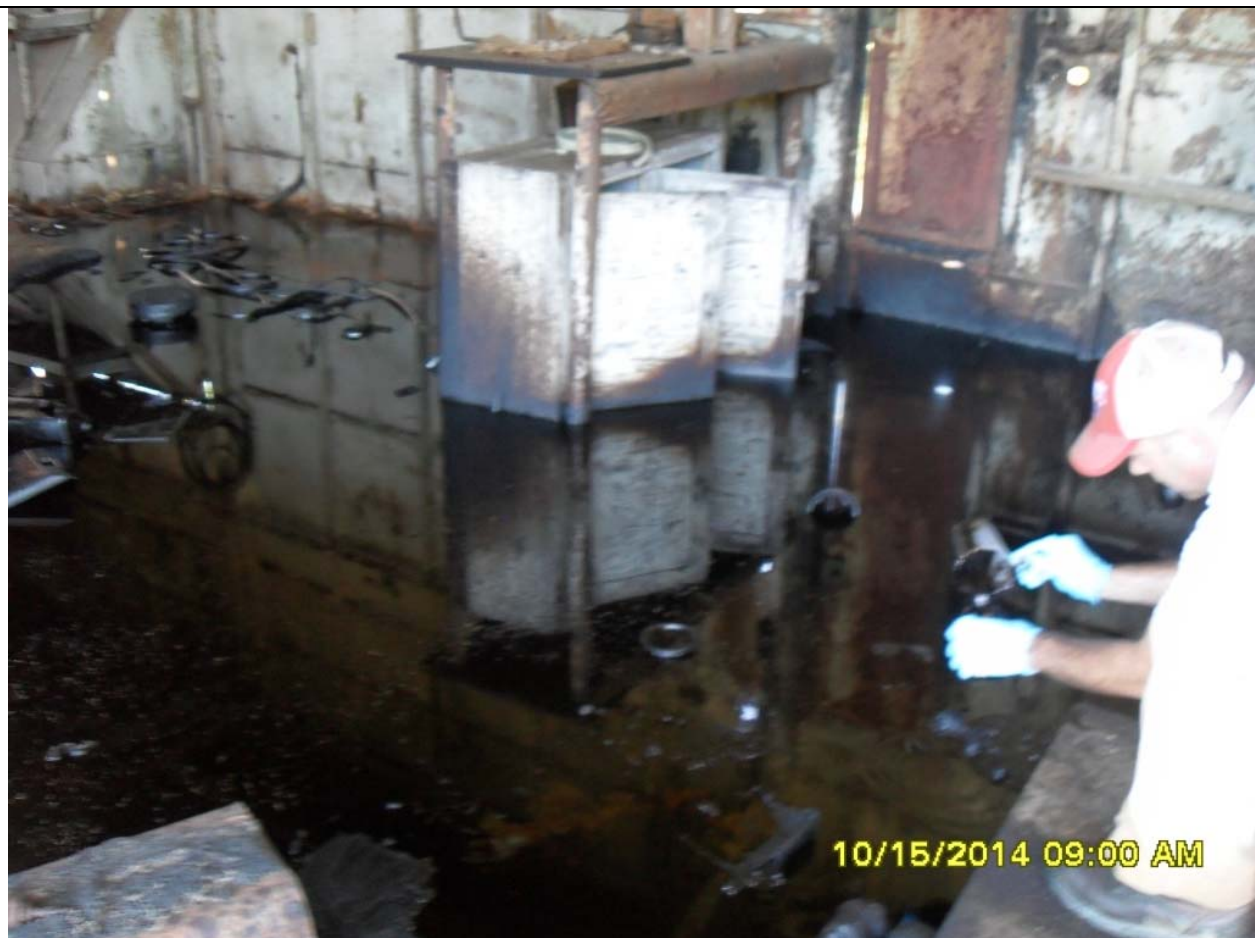
Logbook Photo #	SDC10045
US EPA ID / Task Order Number	CERCLIS No. LAD008434185 / 2/Dynamac-077-15-001
Site	SBA Shipyard, Inc. – Removal Assessment (RA)
Location Address	9040 Castex Landing Road
City, State	Jennings, Louisiana
Parish	Jefferson Davis
Direction/Orientation	NW
Date	10/15/14
Time	0900 hrs
Photographer	N. Biscocho (START)
Witness	J. Sherrard (START)
Description: (Photo 2 of 2 from SBA-RA-02) START collecting sediment sample from SBA-RA-02 inside the alkyne storage tank pump house visible on the buried barge. SBA-RA-01 sample: oil/water mixtures, black oil and clear water; hydrocarbon odor;

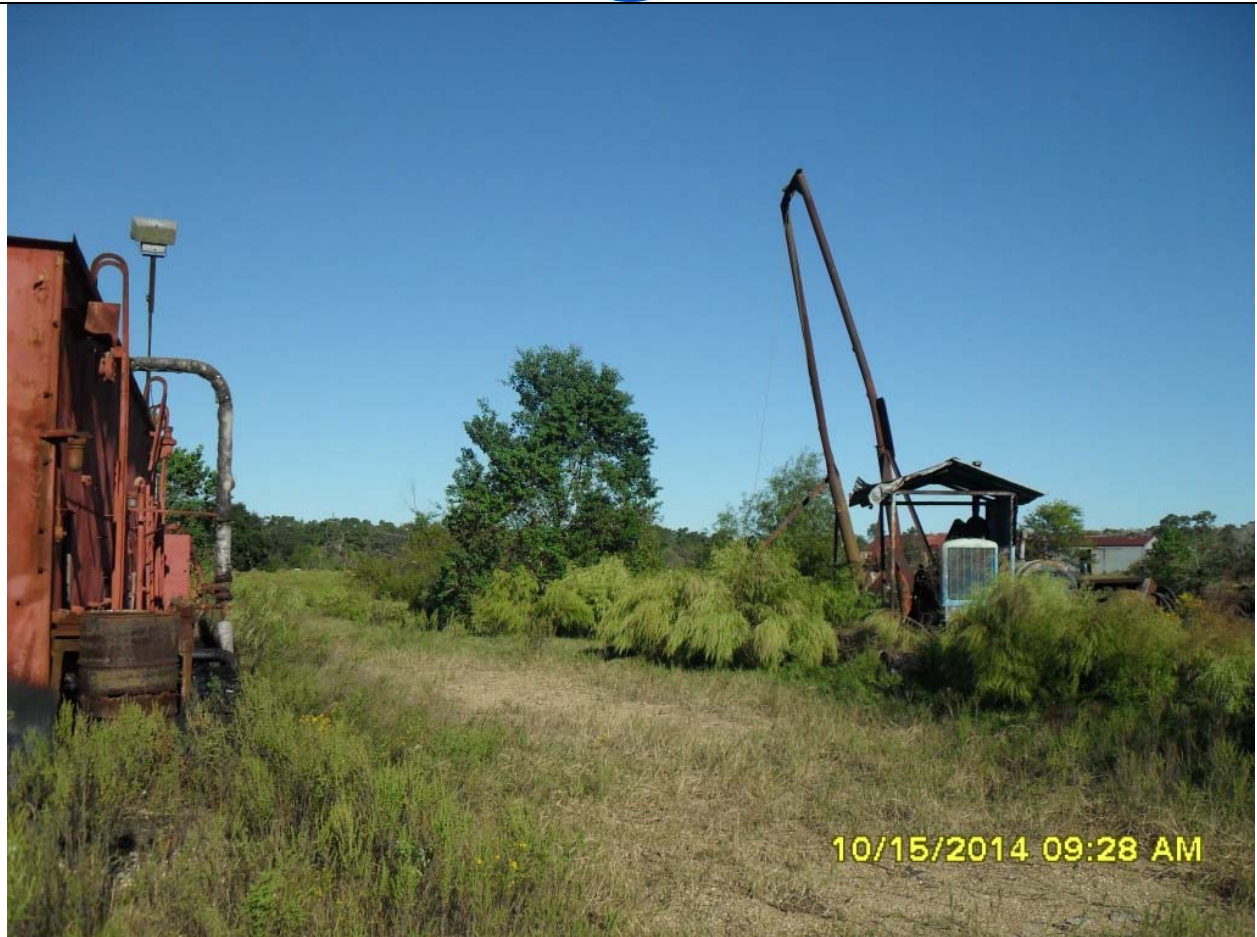
Logbook Photo #	SDC10047
US EPA ID / Task Order Number	CERCLIS No. LAD008434185 / 2/Dynamac-077-15-001
Site	SBA Shipyard, Inc. – Removal Assessment (RA)
Location Address	9040 Castex Landing Road
City, State	Jennings, Louisiana
Parish	Jefferson Davis
Direction/Orientation	W
Date	10/15/14
Time	0928 hrs
Photographer	N. Biscocho (START)
Witness	J. Sherrard (START)
Description: (Photo 1 of 2 from SBA-RA-03) View of sample location SBA-RA-03 located to the northwest of the buried barge associated with the alkyne storage tank pump house.

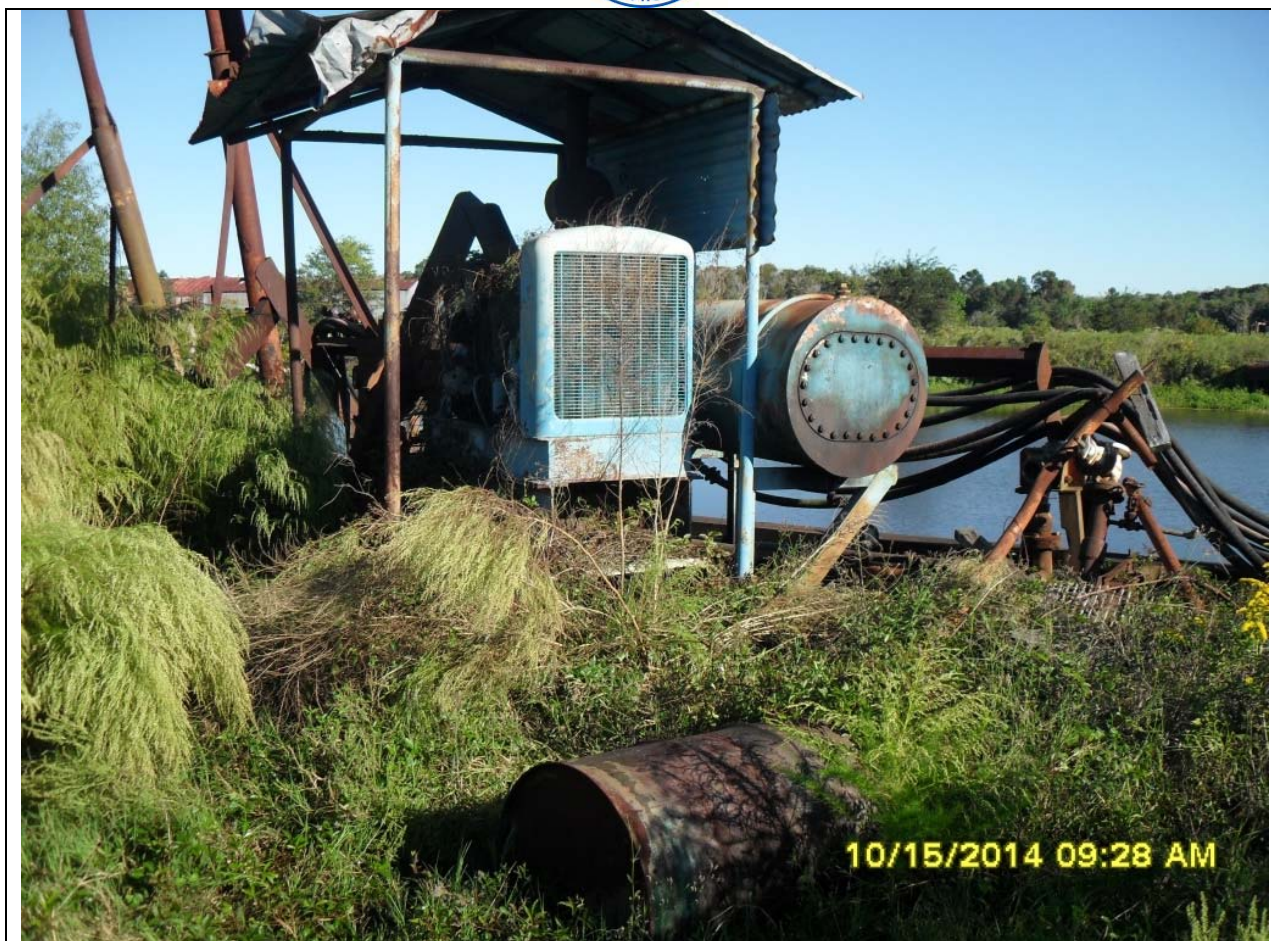
Logbook Photo #	SDC10048
US EPA ID / Task Order Number	CERCLIS No. LAD008434185 / 2/Dynamac-077-15-001
Site	SBA Shipyard, Inc. – Removal Assessment (RA)
Location Address	9040 Castex Landing Road
City, State	Jennings, Louisiana
Parish	Jefferson Davis
Direction/Orientation	NW
Date	10/15/14
Time	0928 hrs
Photographer	N. Biscocho (START)
Witness	J. Sherrard (START)
Description: (Photo 2 of 2 from SBA-RA-03) View of sample location SBA-RA-03 adjacent to the horizontal saddle tank northwest of the buried barge associated with the alkyne storage tank pump house. Facing northwest at sample location SBA-RA-03. SBA-RA-03 sample: clear and odorless.

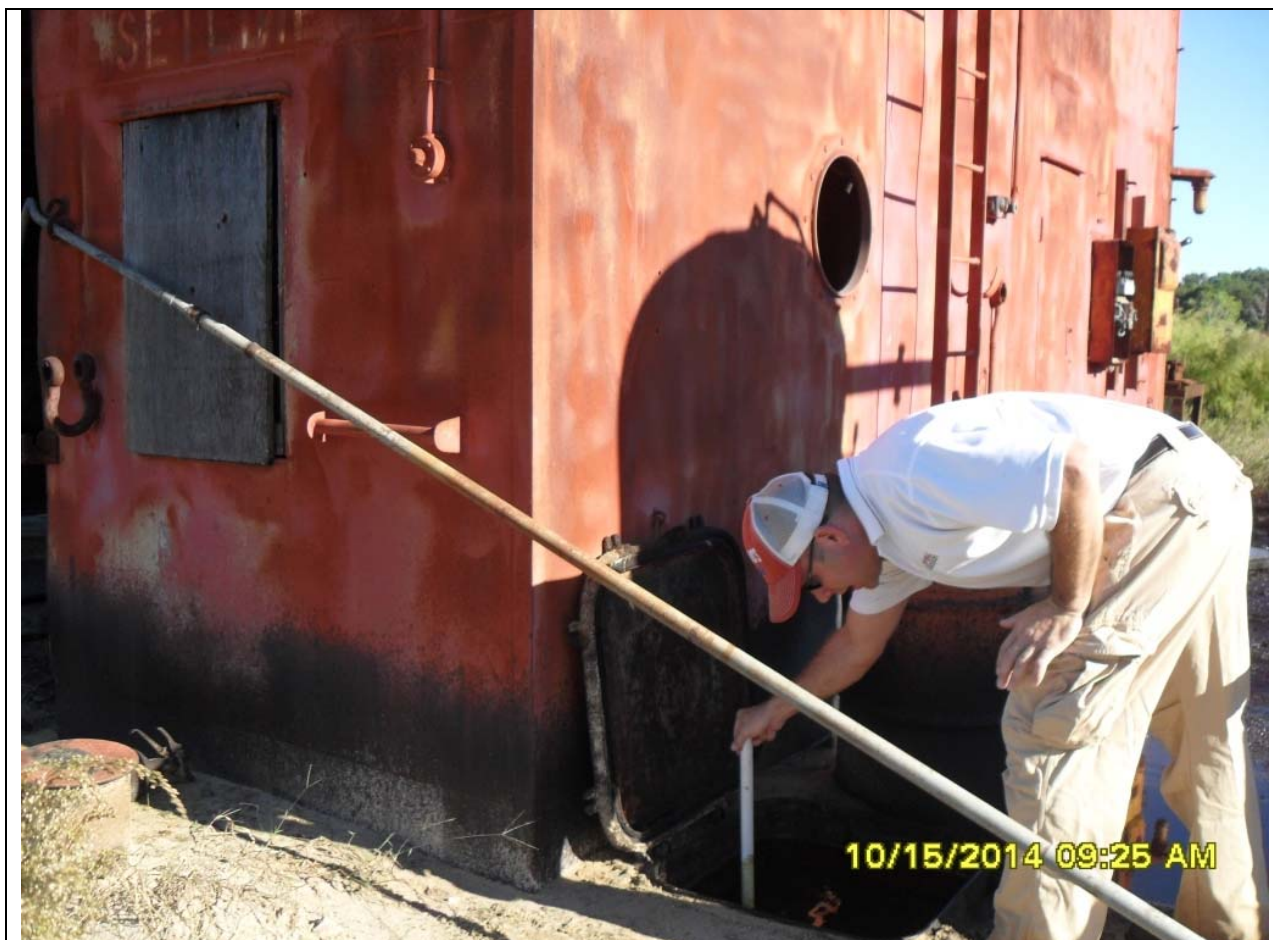
Logbook Photo #	SDC10046
US EPA ID / Task Order Number	CERCLIS No. LAD008434185 / 2/Dynamac-077-15-001
Site	SBA Shipyard, Inc. – Removal Assessment (RA)
Location Address	9040 Castex Landing Road
City, State	Jennings, Louisiana
Parish	Jefferson Davis
Direction/Orientation	NW
Date	10/15/14
Time	0925 hrs
Photographer	N. Biscocho (START)
Witness	J. Sherrard (START)
Description: START collecting depth of buried barge from the hatch opening along the east wall of the associated alkyne storage tank pump house. Depth of buried barge is approximately 7.6 feet.
